# Front Door Makeover

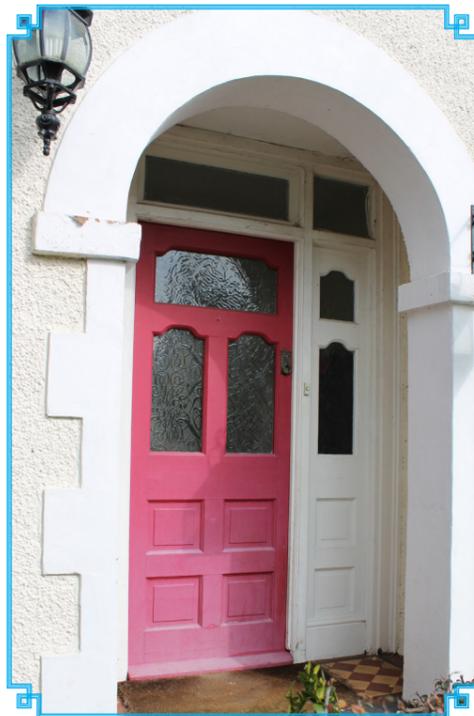
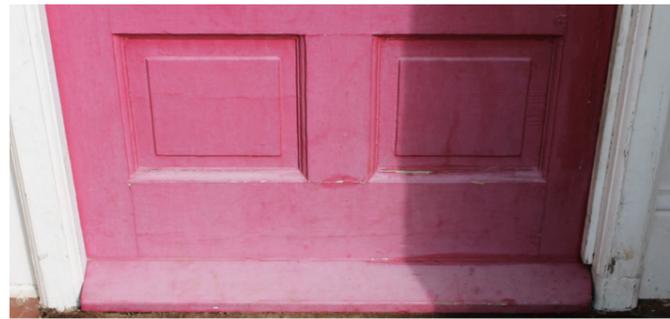
LEFT & ABOVE:  
Front door and surrounding wood panelling in need of maintenance. Old paint work has badly faded and is peeling and cracking. Bottom of the door frame in need of repair with bad wood taken out and filled.

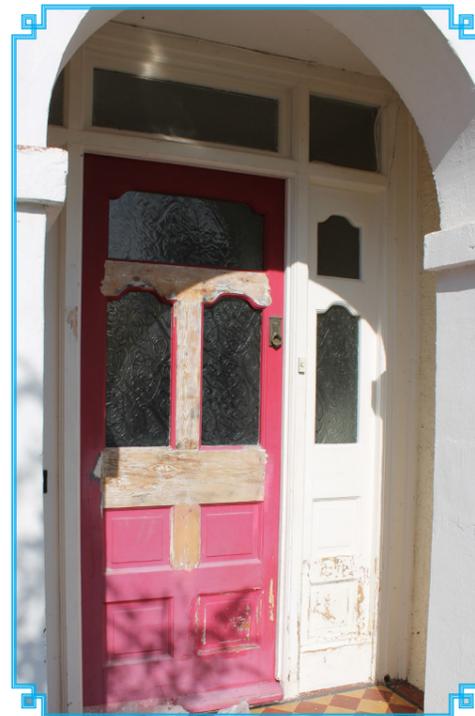
LEFT:  
Years of old paint is removed using a combination of a chemical paint stripper and heat gun.  
RIGHT:  
Door and panelling is sanded down to bare wood.

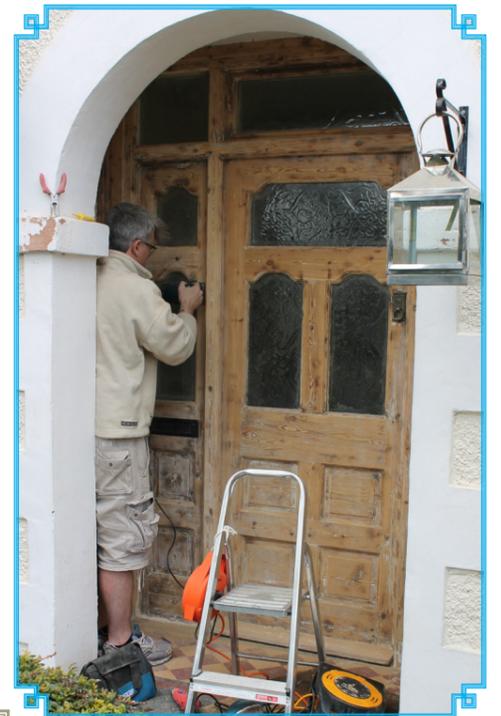
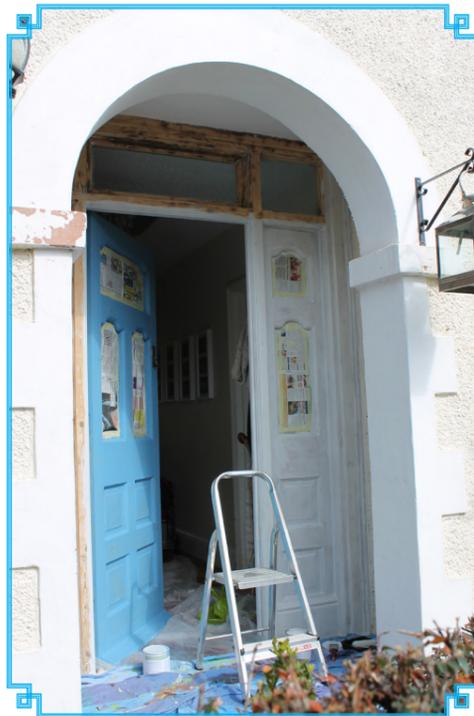
LEFT:  
Knotting Agent applied to a couple of knots that still look quite resinous to avoid any possible resin bleed staining the new coating. The first coat of Protek Royal Exterior Superior Wood Finish is applied to the bare timber.

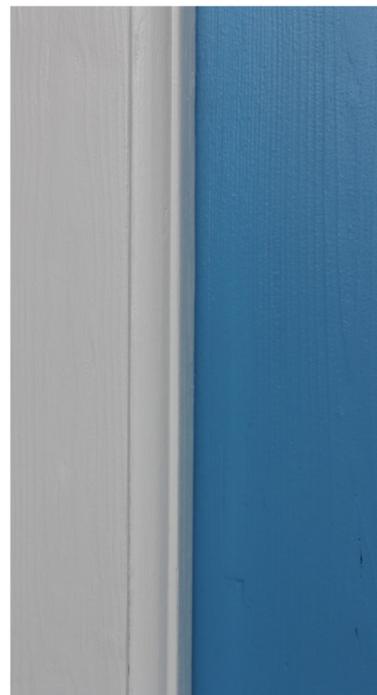
LEFT:  
Royal Exterior Somerset Blue is applied by brush to the door with China Clay in contrast on the wood pannelling & frames. Two coats produces a hard-wearing water repellent coating that allows the wood grain to show through.

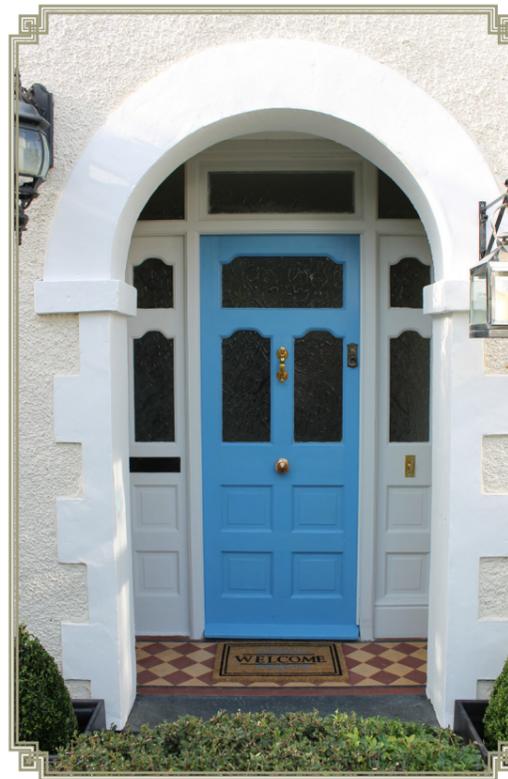
LEFT:  
The transformation is complete!

A faded shabby doorway is transformed in to a beautiful and elegant entrance that will look good for years.
